Klip-Lok / Klip-Tite Dirt Retention Technical Bulletin 1.1

Technical Bulletin 1:1: Dirt Retention

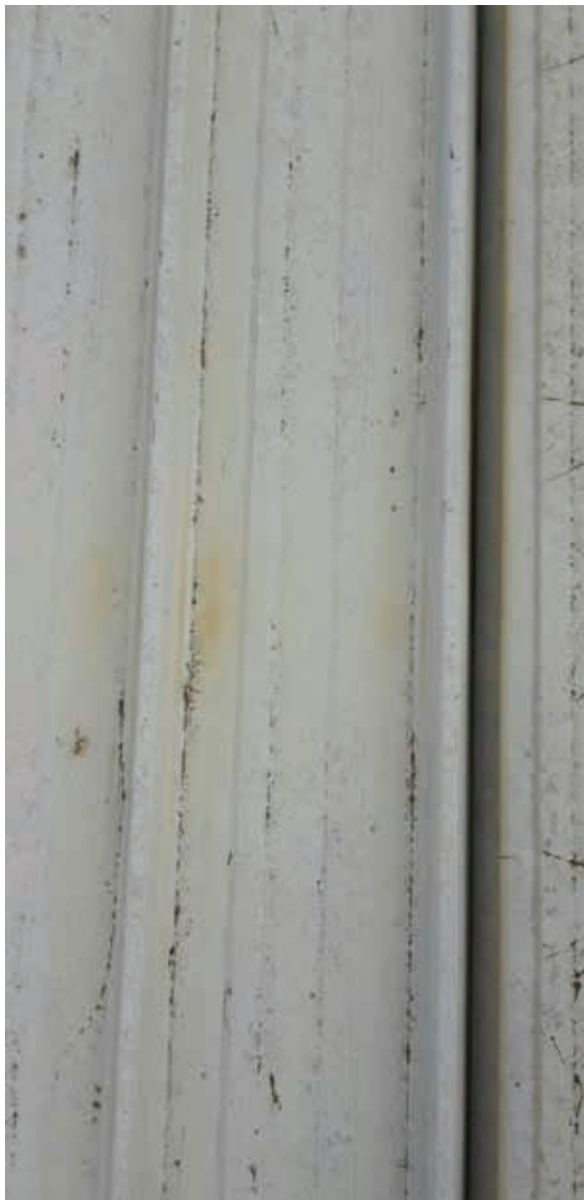
Klip-Lok

Photographs of two projects of equal age – both installed for about 4.5 years. It is noticeable that most of the dirt (black and brown marks) that accumulates on the roof is trapped at the bottom of the narrow flutes, and the bottom of the sides of the longitudinal pan stiffening ribs with minimal accumulation at the transverse pan stiffeners. The dirt accumulation thus follows the height of the upstand – 41mm at the narrow flute, 2mm at the longitudinal pan stiffeners and 0.5mm at the transverse pan stiffeners.
